John Smith
123 Pleasant View
Manlius, 13104
HIN™: 555555555
Email: JohnSmith@yahoo.com
Inspection Date: 07-18-2015

MyHome and Property
Gairot Myers
8121 Circuit Rider Path
Cicero, New York 13039
Phone: (315) 491-3387
E-Mail: gairot@myhomeandproperty.com

Report Summary

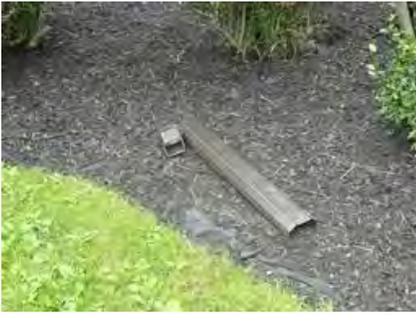
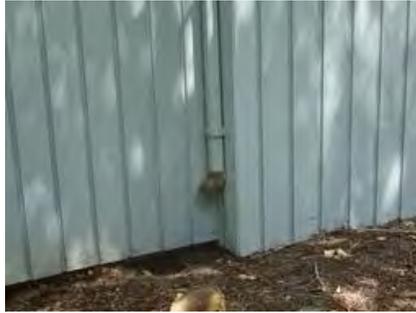
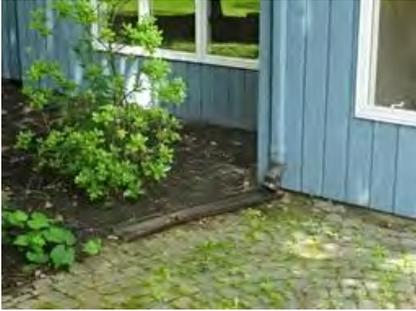
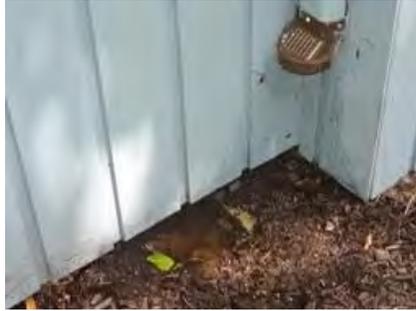
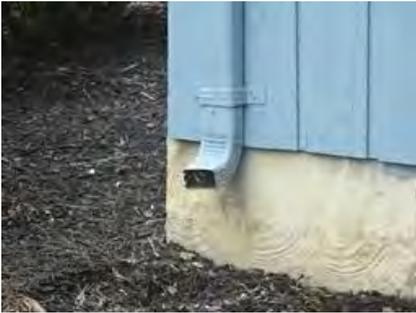
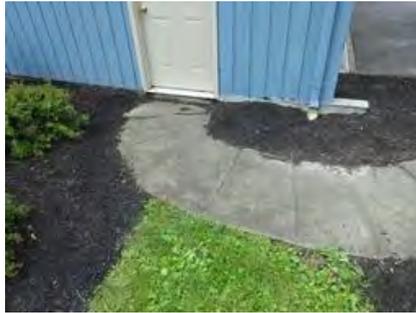
Many gutter downspouts are missing extensions. This is causing the water traveling in the gutters to collect near the foundation. This can lead to moisture in the basement. Recommend qualified contractor evaluate and repair as needed.

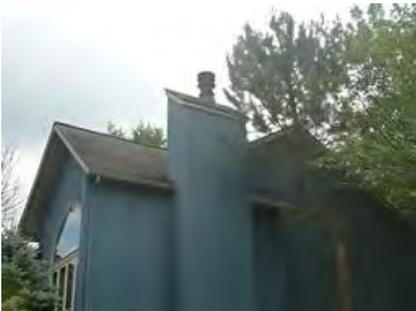
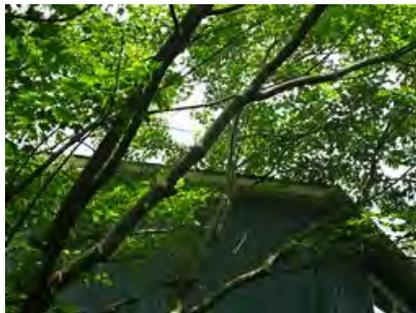
Tree branches are in contact with rear right part of the roof. These branches will decrease shingle life due to contact and moisture retention. Recommend qualified contractor provide remedy.

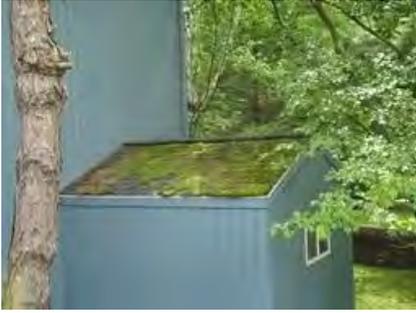
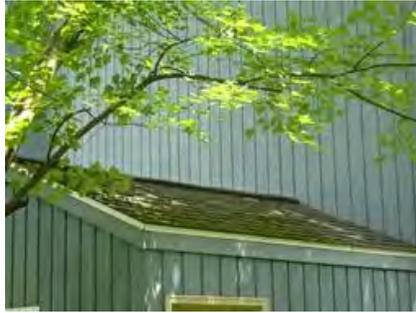
Excessive moss noted on asphalt shingles of attached storage shed. This can lead to deterioration of roof decking due to water being leached under the shingles by the moss. Recommend a qualified contractor repair as necessary.

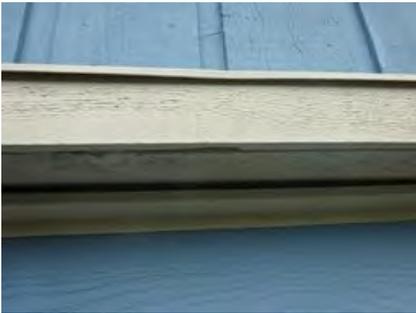
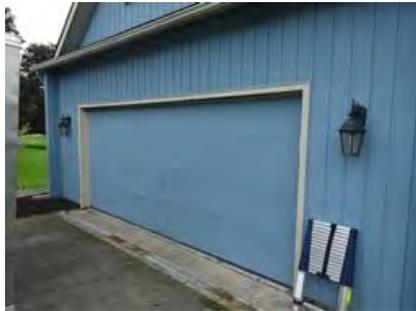
07/19/2015 Weather seal trim around garage door is loose. Recommend qualified contractor attach trim to prevent water penetration and further damage.

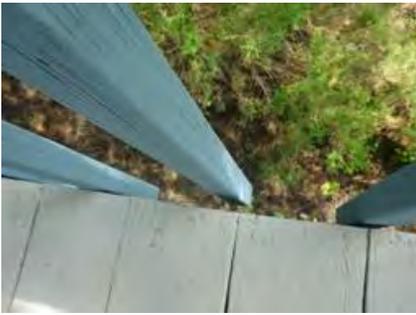
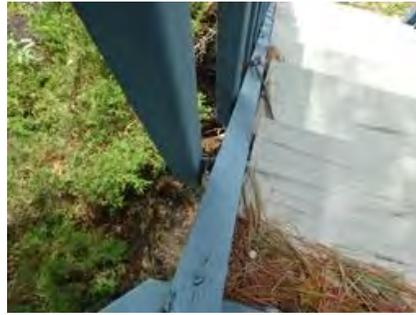
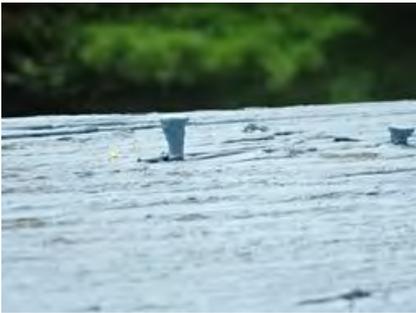
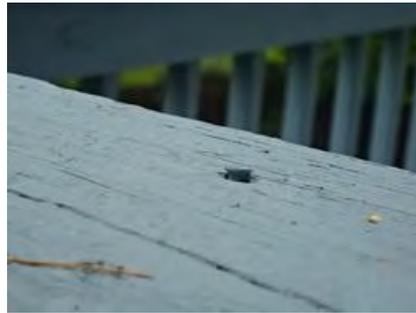
Several balusters on the deck are loose. These would not provide the proper safety they are intended for. There are also several screws that have backed out. These screws can easily cause injuries. Recommend qualified contractor fasten these screws and balusters properly.

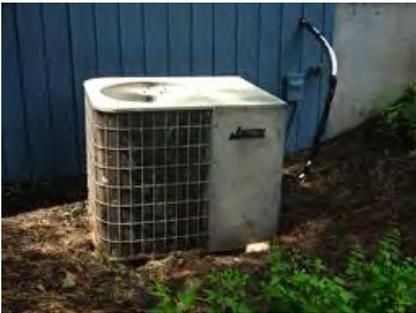
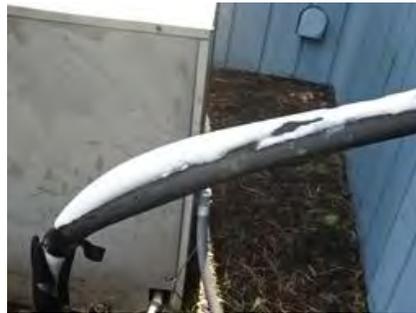
Refrigerant line for the A/C compressor had ice build up. This may be due to a leak in the line or low coolant charge, among several different things. Recommend qualified HVAC contractor evaluate and repair as needed.

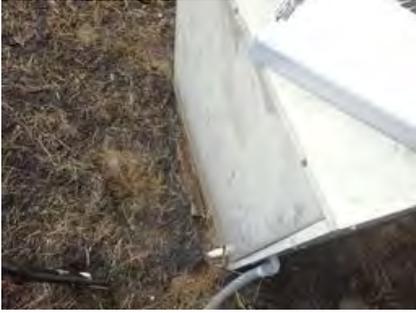
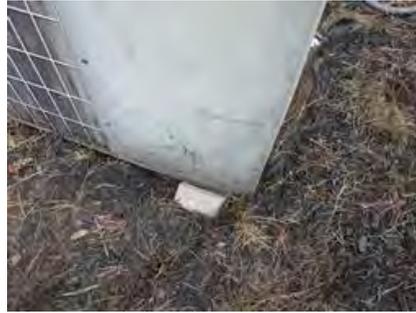
The a/c compressor does not have a sufficient cement pad. It was supported with a brick and wood, these supports have since been displaced. This can cause the compressor to become unlevel and may cause damage. Recommend qualified HVAC contractor evaluate and repair as needed.

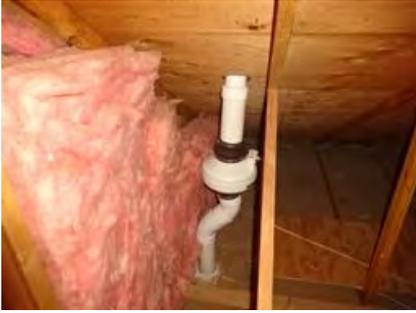
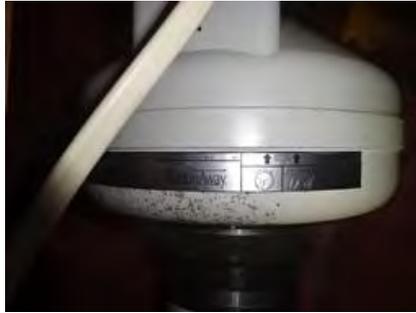
07/19/2015 Radon mitigation system is installed, however, it was not running at time of the inspection. The motor of the mitigation system should be running 24/7. Recommend qualified contractor evaluate and repair as needed.

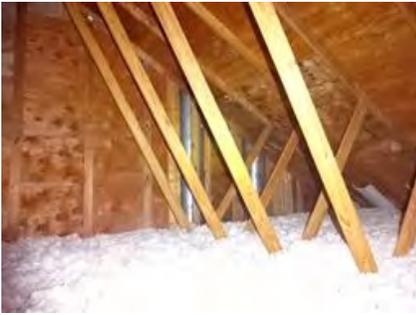
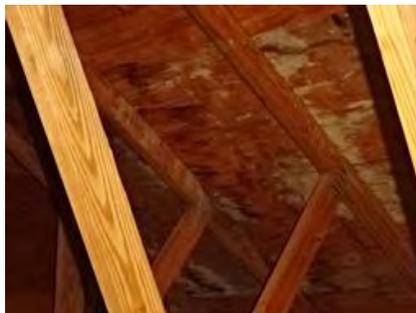
07/19/2015 A moisture stain was noted in the attic. This may be an old stain. A moisture meter was used to determine the decking was not wet at the time of the inspection. Recommend monitoring this area for future moisture penetration.

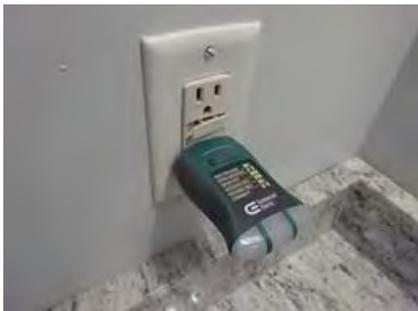
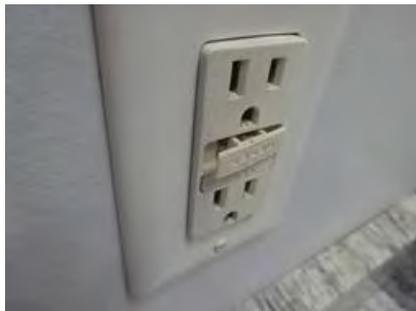
07/19/2015 Ground Fault Circuit Interrupter is not working properly. This is a safety issue due to an electric shock and fire hazard. Recommend having a qualified, licensed electrician evaluate and repair or replace as necessary.

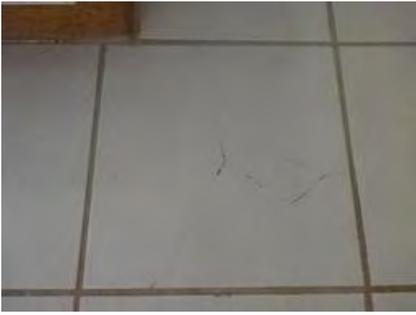
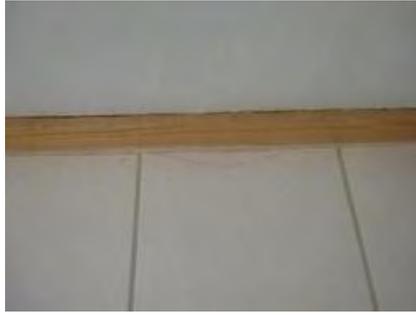
07/19/2015 Two cracked floor tiles were noted. Recommend qualified contractor provide remedy to prevent further damage.

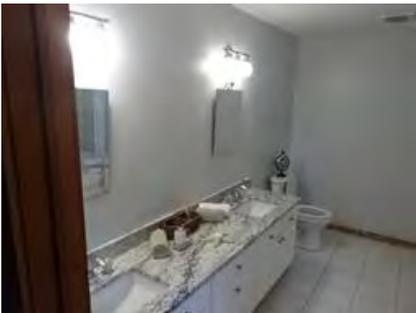
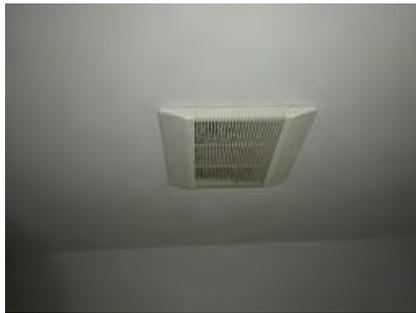
07/19/2015 Bathroom exhaust fan is not working. Recommend qualified contractor repair as needed.

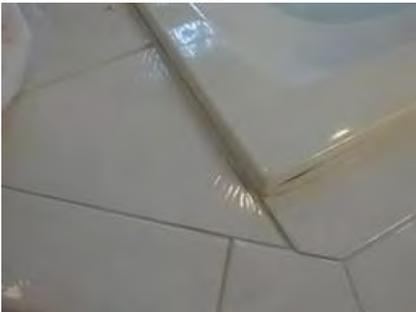
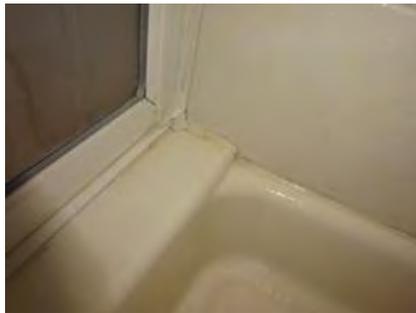
07/19/2015 Noted some areas of loose or missing caulking. These areas may allow for moisture penetration. Recommend qualified contractor repair these areas.

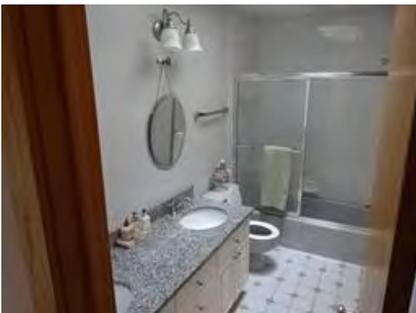
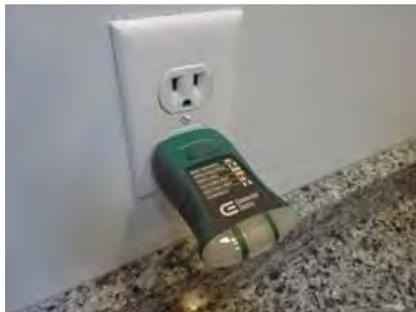
07/19/2015 No ground fault circuit interrupter (GFCI) outlets installed. GFCI outlets help prevent electric shocks in areas that may have water present. Recommend having a qualified electrician install one or more GFCI outlets, especially over counter tops and around sinks.

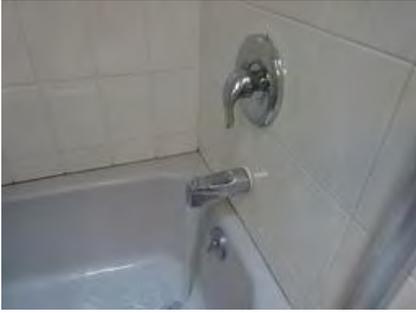
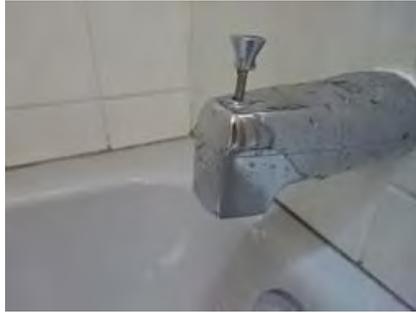
07/19/2015 Tub faucet diverter is difficult to use and does not completely divert water to the shower head. Recommend qualified plumber provide remedy.

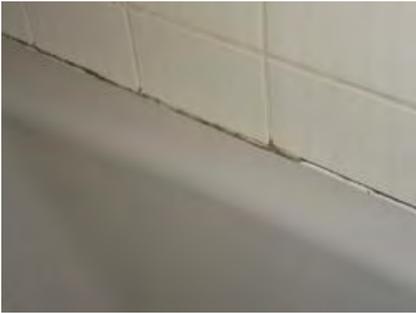
07/19/2015 Noted missing caulk in bathtub area. This will allow water penetration to effect sub flooring and may damage wood. Recommend a qualified contractor repair or replace as necessary.

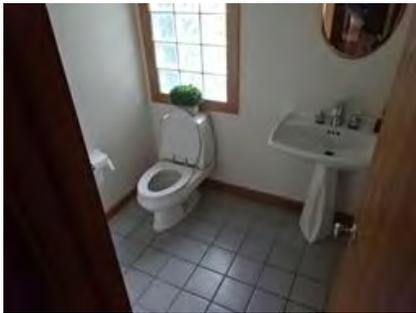
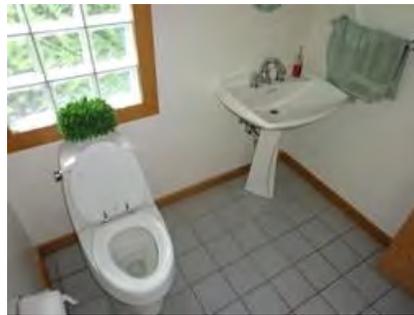
07/19/2015 Ground fault circuit interrupter (GFCI) outlets installed are not working properly. GFCI outlets help prevent electric shocks in areas that may have water present. Recommend having a qualified electrician install GFCI outlets.

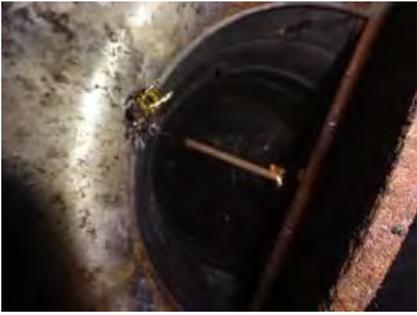
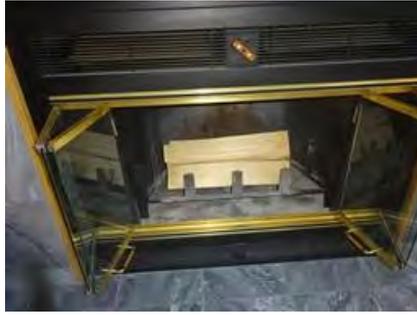
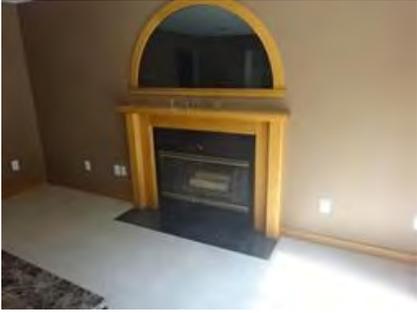
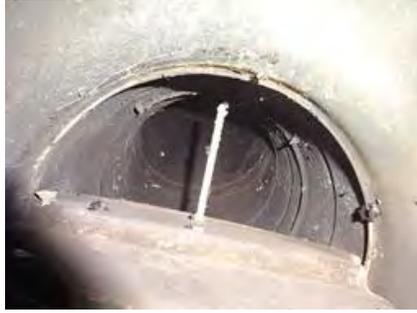
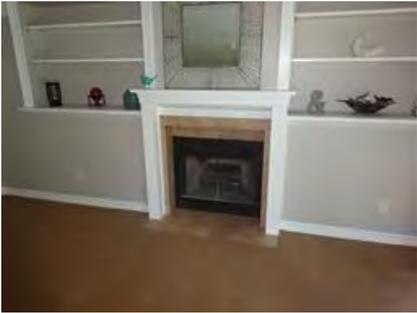
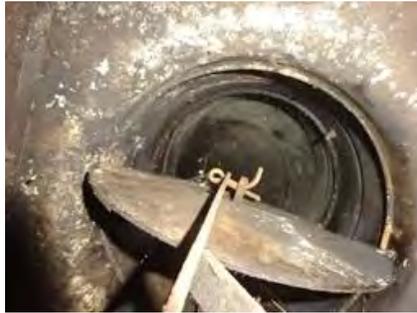
07/19/2015 There are three fireplaces. The following applies to all three. Recommend a cleaning and level 2 inspection to assure there are no cracks or spaces in the flue liner. When dampers were opened, ash and dirt fell into the fireplace, cleaning recommended yearly.

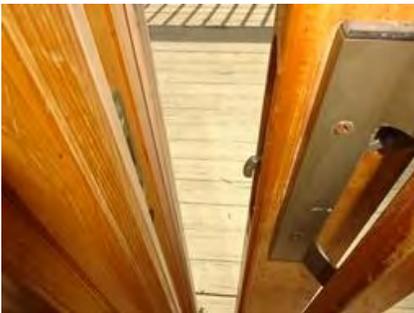
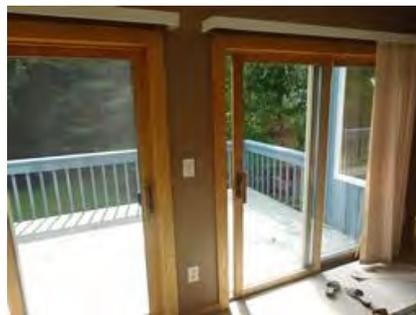
07/19/2015 Rear right sliding deck door does not lock. Recommend qualified contractor evaluate and repair as needed.

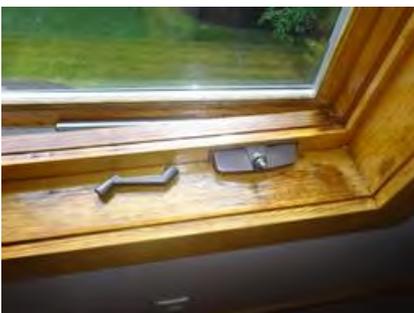
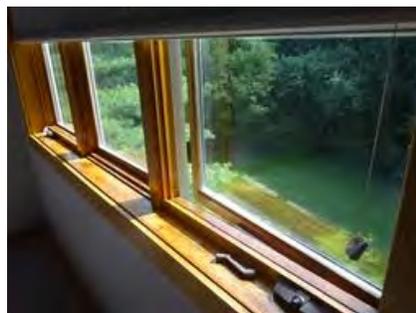
07/19/2015 Window in rear left bedroom has malfunctioning crank. The window will open but the crank will not close the window. Recommend qualified contractor repair as needed.

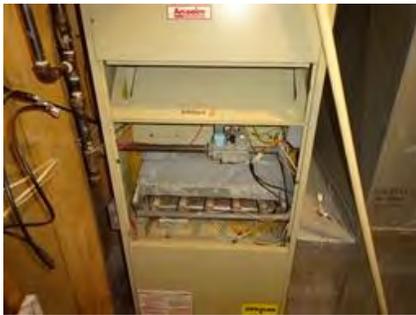
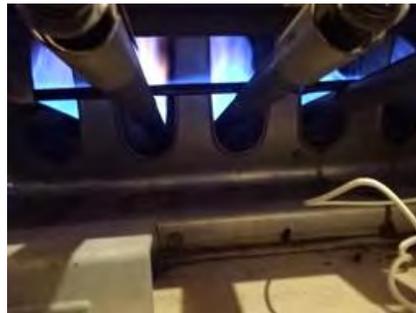
07/19/2015 Old furnace worked on the day of the inspection. Because of its age and condition I would budget for a replacement. This furnace may need replacing at any time.

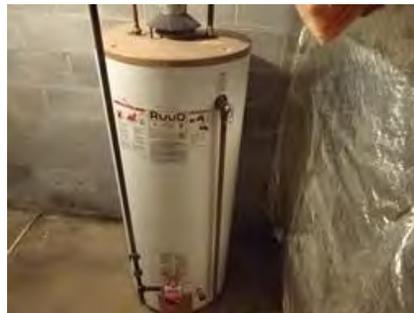
07/19/2015 Hot water heater appears to be older than 10 years and is older than its estimated useful life. This hot water heater may need replacing at any time. Unit worked as designed at time of the inspection.

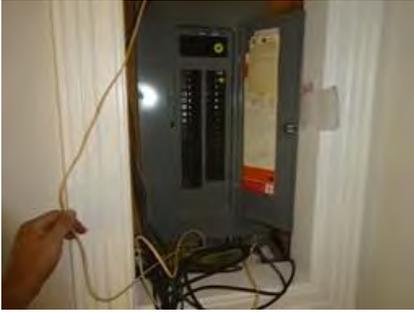
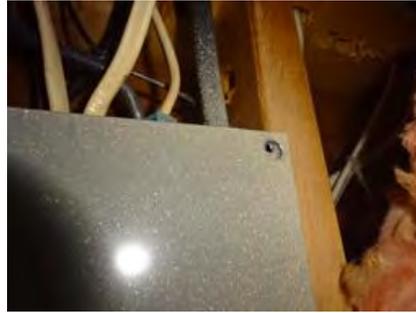
07/19/2015 Several screws are missing on the panel cover plate. Recommend qualified contractor fasten the cover plate with the proper fasteners.
