John Smith
123 Pleasant View
Manlius, 13104
HIN™: 555555555
Email: JohnSmith@yahoo.com
Inspection Date: 07-18-2015

MyHome and Property
Gairot Myers
8121 Circuit Rider Path
Cicero, New York 13039
Phone: (315) 491-3387
E-Mail: gairot@myhomeandproperty.com

Report Summary

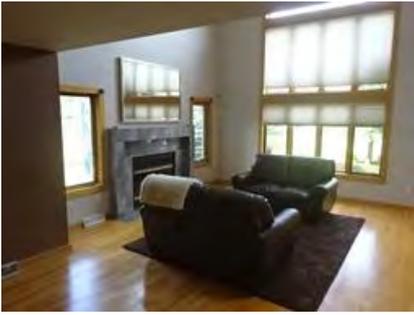
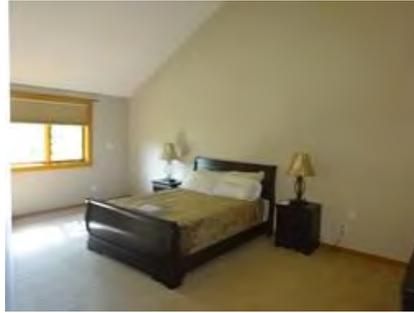
07/19/2015 Numerous wall, floor and other surfaces were obscured by furniture and/or stored items, preventing a full evaluation of some areas.

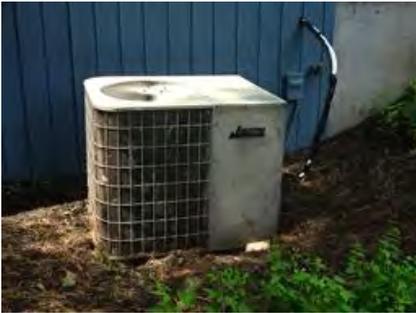
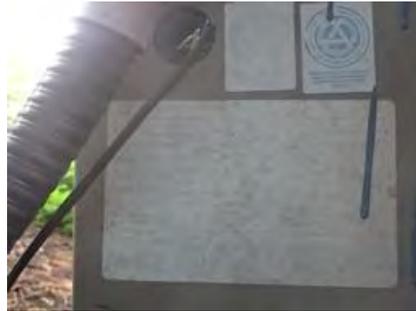
07/19/2015 A/C compressor is beyond the end of its useful life and may die at any time. Compressor sounded good and produced cold air at time of the inspection.

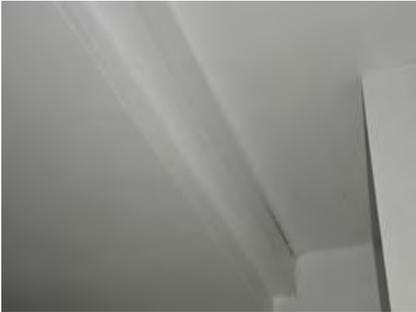
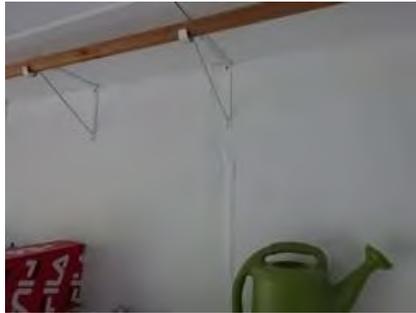
07/19/2015 Sheetrock in the garage had minor cosmetic imperfections.

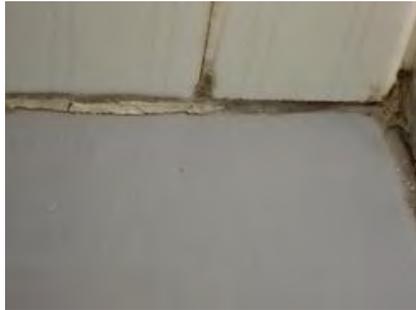
07/19/2015 Noted missing caulk in bathtub area. This will allow water penetration to effect sub flooring and may damage wood. Recommend a qualified contractor repair or replace as necessary.

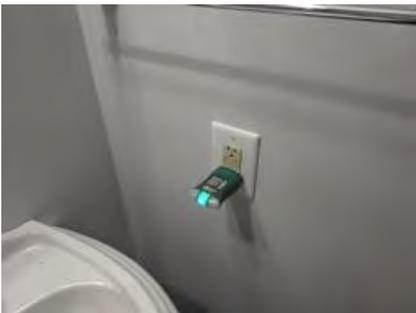
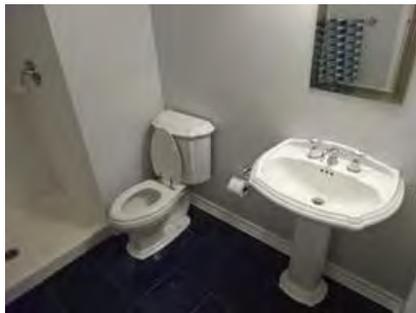
07/19/2015 No concerns noted in basement bathroom.

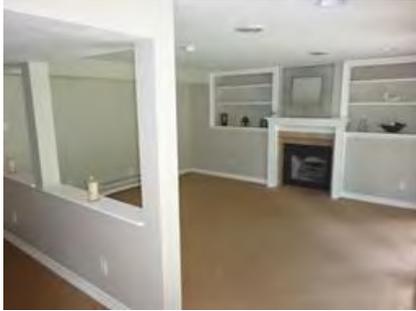
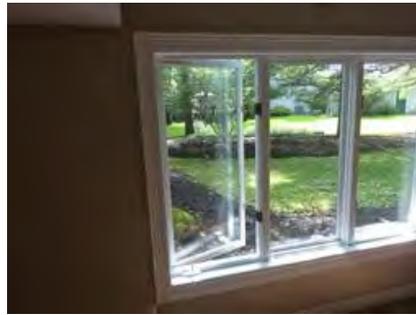
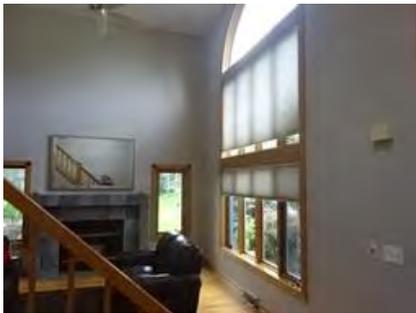
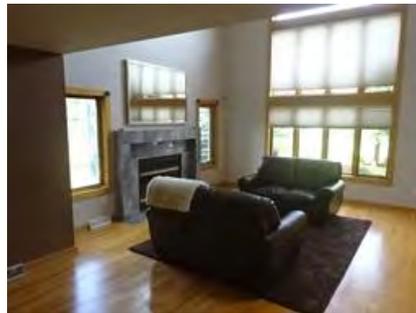
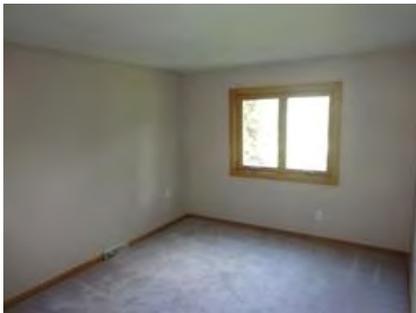
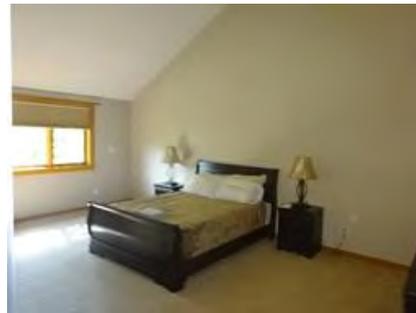
07/19/2015 General interior photos.

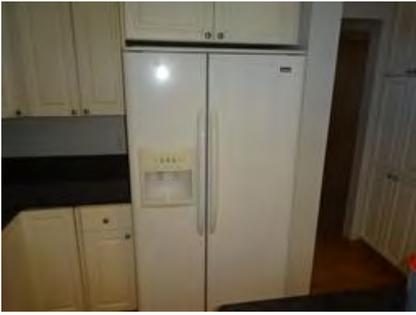
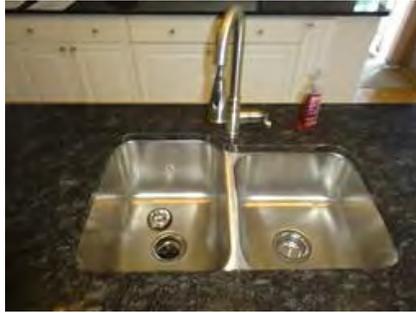
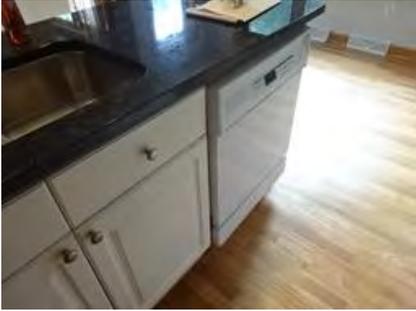
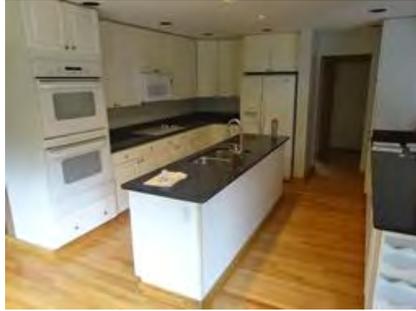
07/19/2015 No defects noted in kitchen at time of the inspection

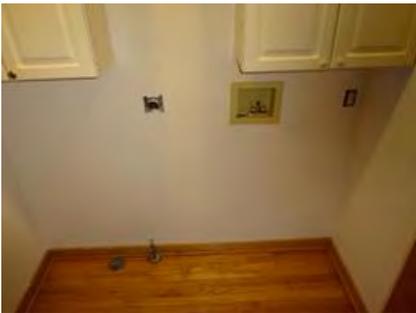
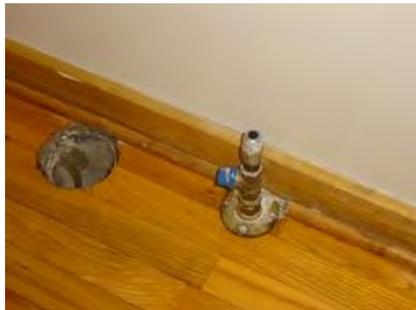
07/19/2015 No defects noted with laundry area.

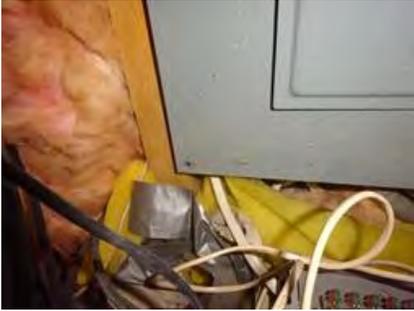
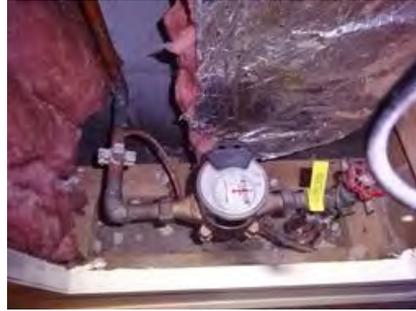
07/19/2015 Several screws are missing on the panel cover plate. Recommend qualified contractor fasten the cover plate with the proper fasteners.

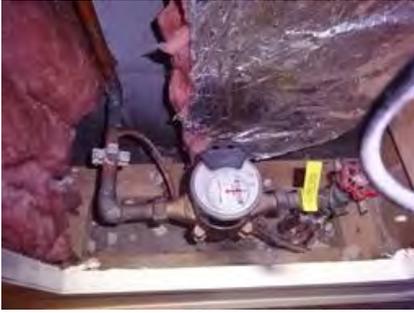
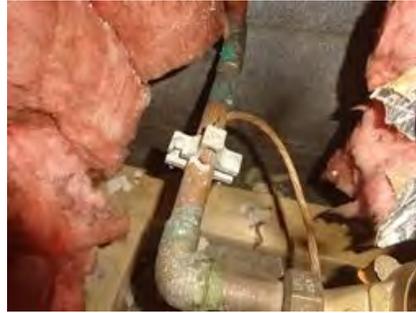
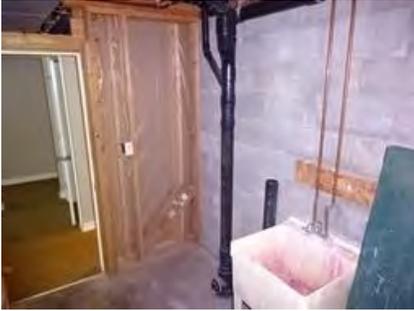
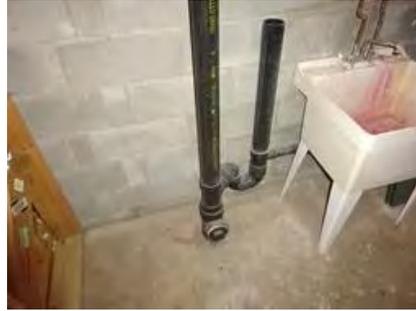
07/19/2015 No defects noted with the plumbing system at time of the inspection.

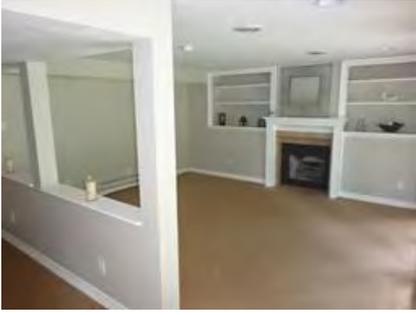
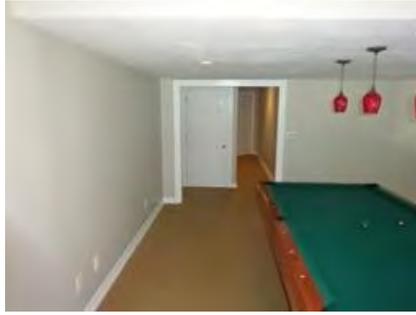
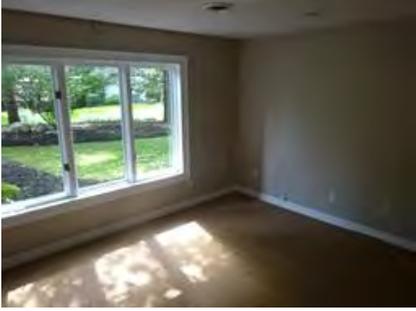
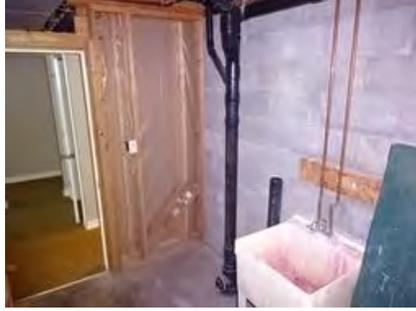
07/19/2015 General basement photos
